SUPPORT TO THE COMPETITIVENESS OF THE RICE SECTOR IN THE CARIBBEAN, PROJECT 9ACP RPR 006

**REHABILITATION AND COMPLETION OF THE IRRIGATION AND DRAINAGE
INFRASTRUCTURE IN NICKERIE**

Paramaribo, 28 February 2005

Dr. S. Naipal

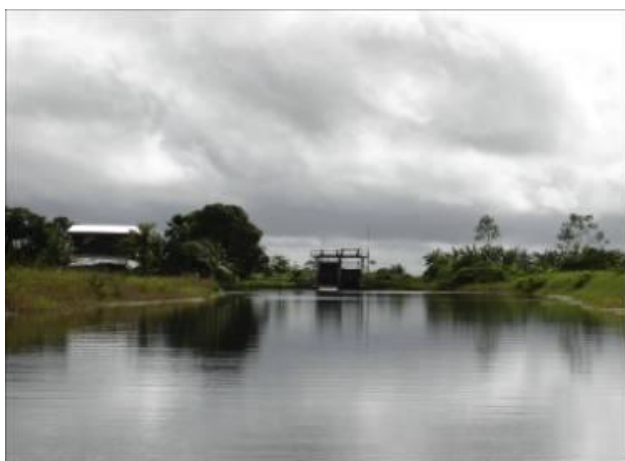
The Nanni sluice approaching from the Van Wouwkanaal. The clean looking Van Wouwkanaal is due to the use of appropriate application of chemicals.

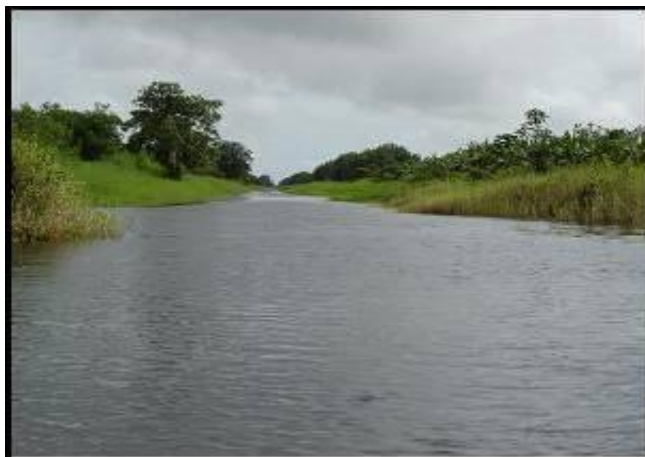
A view at the end of the Corantijkanaal, nearby the Nanni sluice looking relatively good maintained.

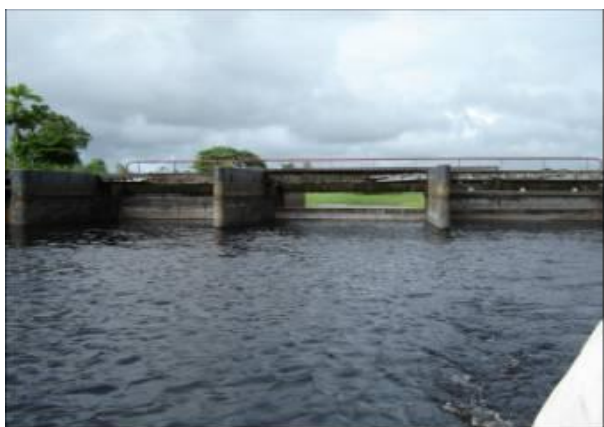
Weir at the Nanni inlet. This weir allows excess water to flow through the Nanni creek to the Corantijn river. Operation of this weir is always a problem.

The retention dams at the Nanni weir also need to be raised at least with one (1) meter. At high water levels, the left side bank is being overflooded. Under these circumstances, it is difficult to open the weir, as the stop logs are difficult to pull. A new mechanism has to be found to facilitate the operation of the weir properly during high waters in the swamp.

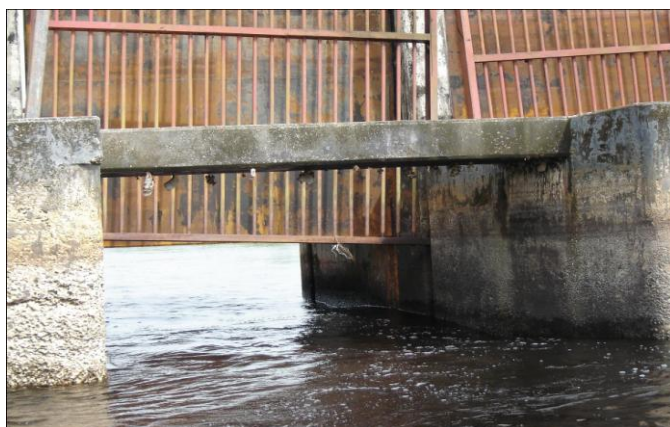
The Nanni sluice of the Nanni inlet. The fundamentals looks good but the trash hark is missing and the doors are not functioning well.

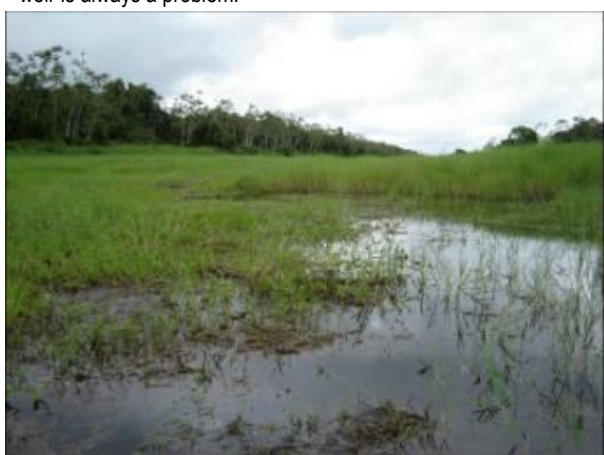
Overgrown by aquatic weed Corantijkanaal some 15 minutes boating from the Nanni sluice upstream the canal.

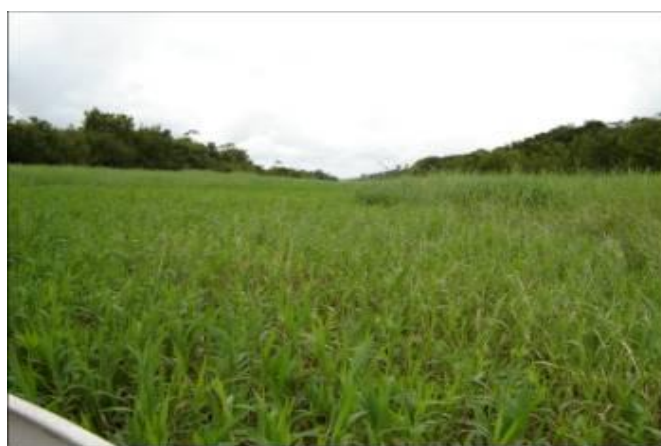
A more densely overgrown Corantijkanaal

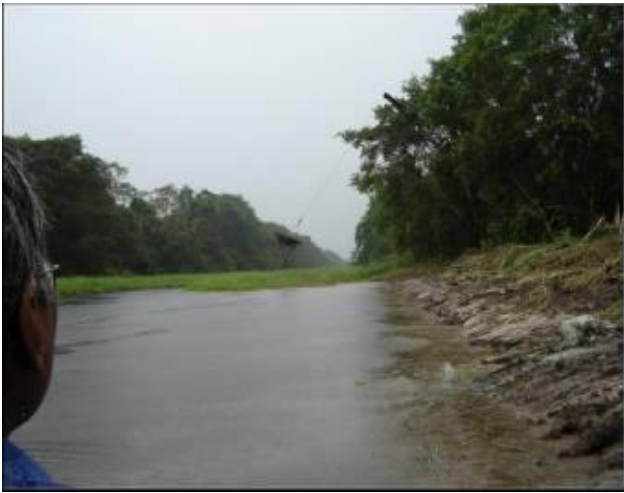
Cleaning up of the Corantijnkanaal by using dragline, equipped with local made tray. It should be noted that the tray can only reach up to the middle of the canal

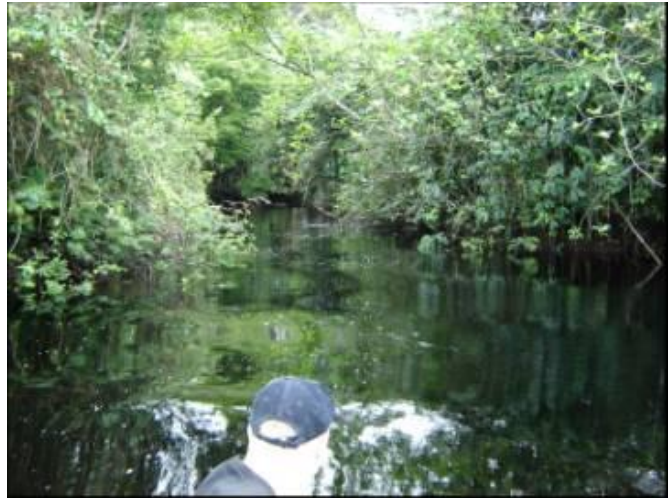
Situation at km 27.5 of the right bank of the Corantijnkanaal, showing the location where an inlet (a possible weir / culvert ..) construction from the Nanni swamp into the canal was planned.

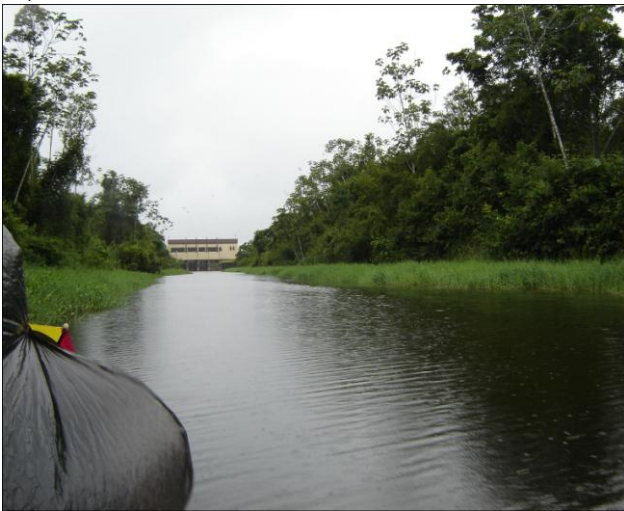
Approaching wakay pumping station. Note, aquatic weeds limited or washed away when pumps in operation.

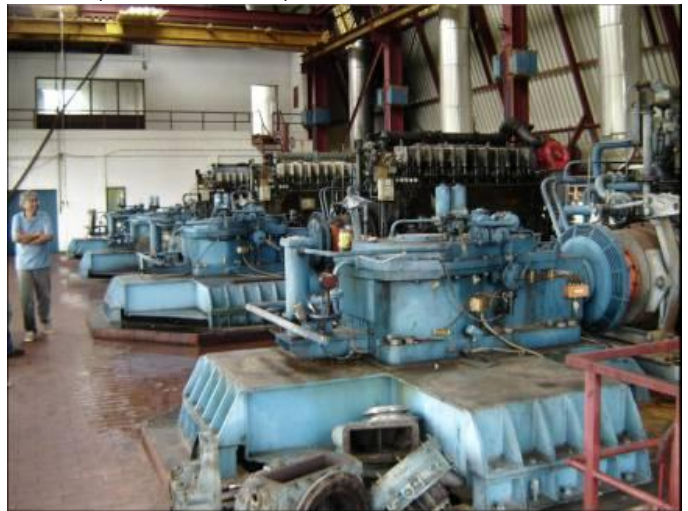
The Storks pumps at the Wakay pumping station. The nearest pump (out of the 4 pumps in total) is not functioning at all.

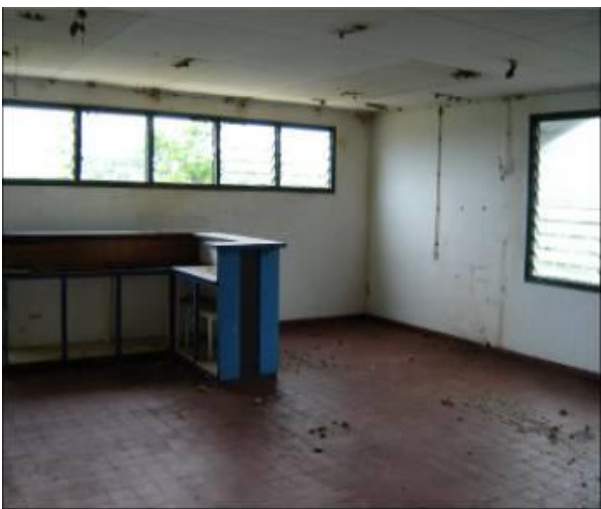
Destroyed office room in the building of the Wakay pumping station.

2. Rehabilitation of the buildings, including the Wakay pump house, which mainly include
 - a. The renewing of the roof, and rehabilitation of the office, inclusive air-conditioning, the workshop and other small aspects related tot the building. Where possible to paint the Wakay pump building.

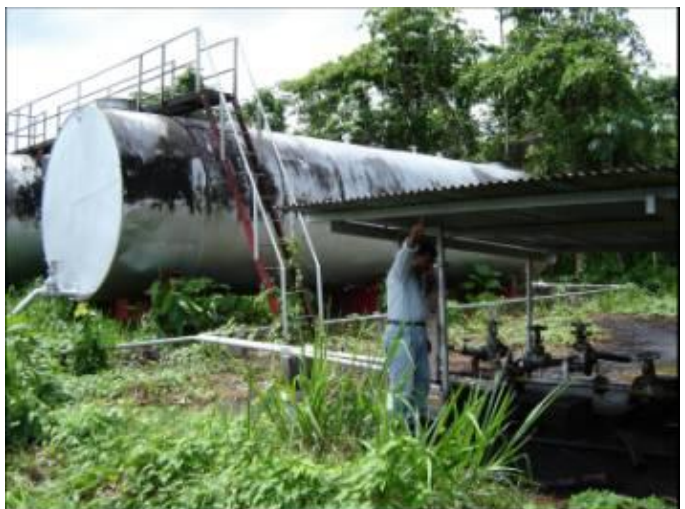
Fuel bunker at Wakay with missing pumps to transfer fuel to fuel tanks of the pumps.

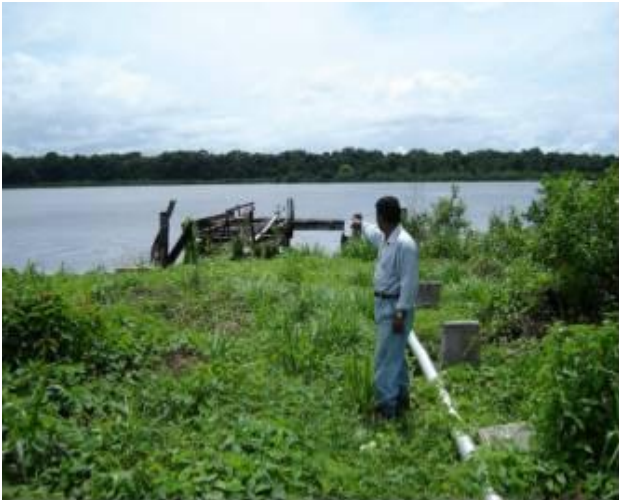
Mr. Padarath, technical assistant at the Wakay puming station, shows the Scaffold, arrear in maintenance. Tankers (fuel boats) can hardly moor here.

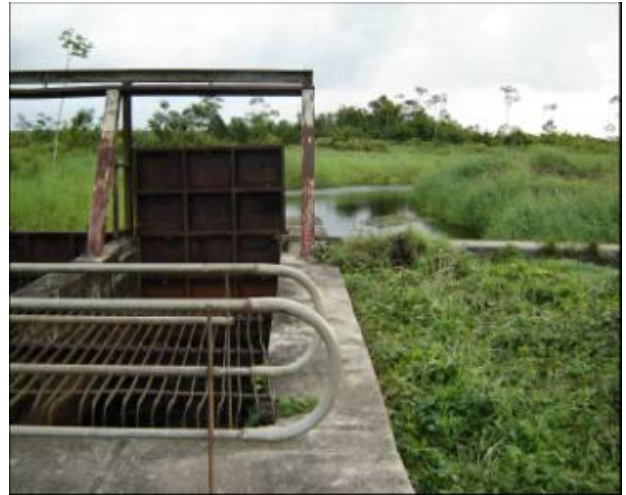
The Inlet sluice at IKUGH. The sluice doors are not functioning properly, however fundament of the construction in good condition.

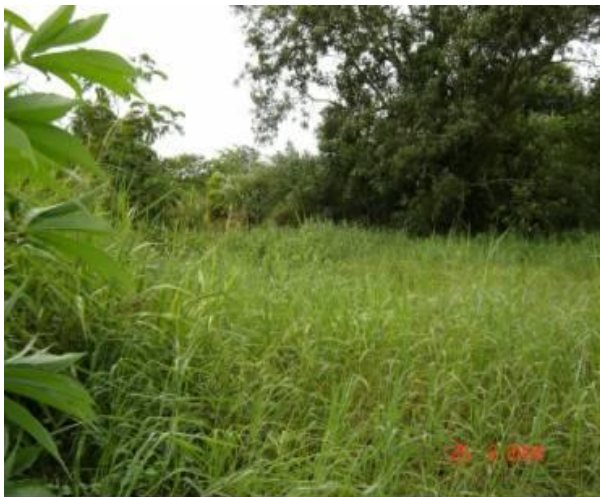
Overgrown inlets at the "driekokerpunt" (Uitbreiding Hamptoncourt polder).

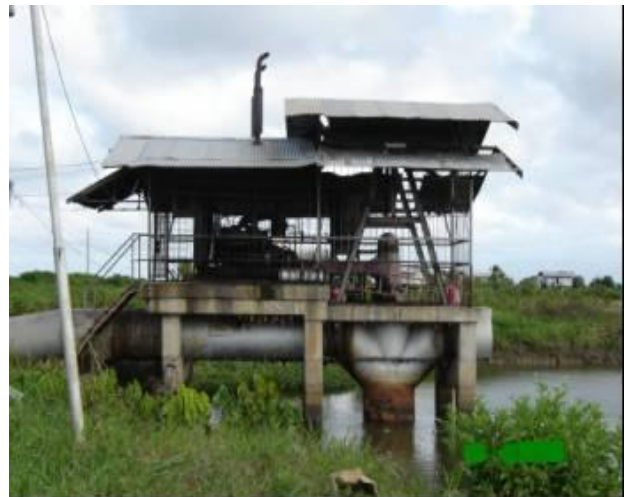
An old pumping installation at the Kaaiman polder (Wageningen) providing irrigation water to the immediate rice fields and in the past also to the "Middenstandspolders" (middleclass farmers).

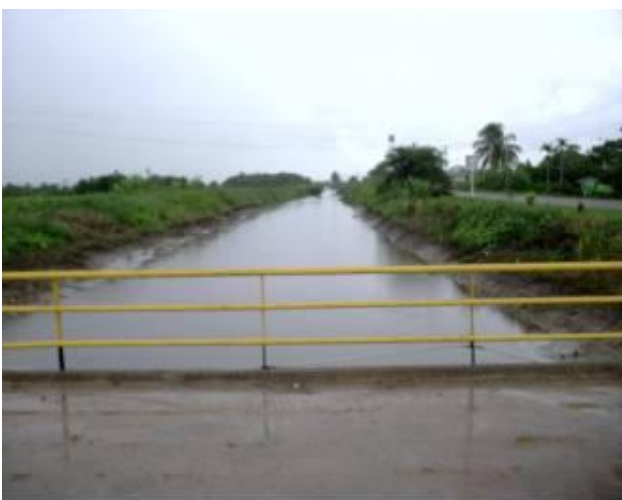
A clean drainage canal at the Henar polder.

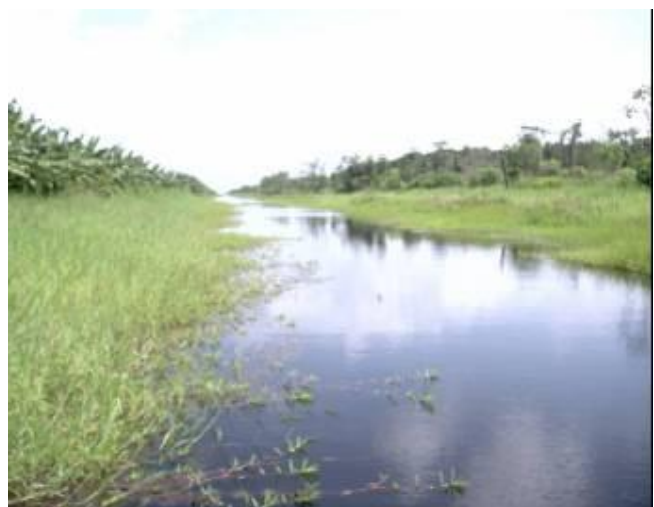
The Stondansie irrigation canal, relatively clean but locally overgrown.

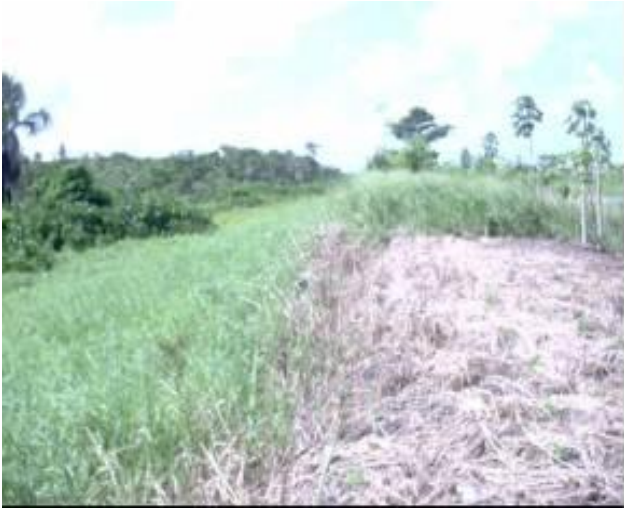
A look at the Maratakakanaal

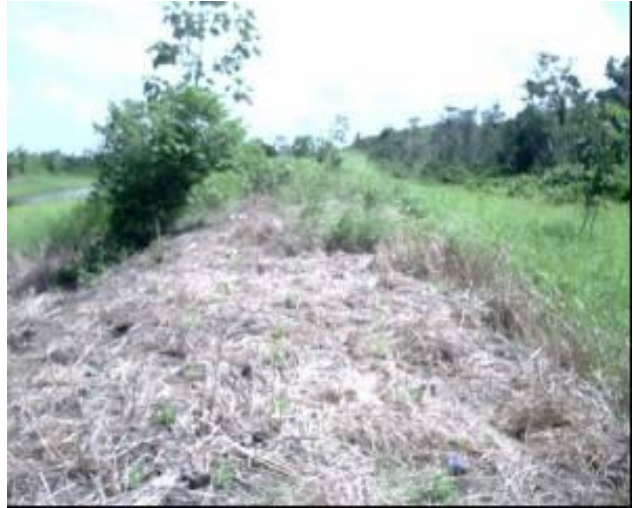
Stondansiekanaal on the left and Maratakkakanaal on the right. The Marakakanaal is hydraulically connected with the Nanni swamp
